# Manhole Inspection Summary

Manhole # S71U\_\_013MH

**Location** Address: **6726 Brentwood Ave.**

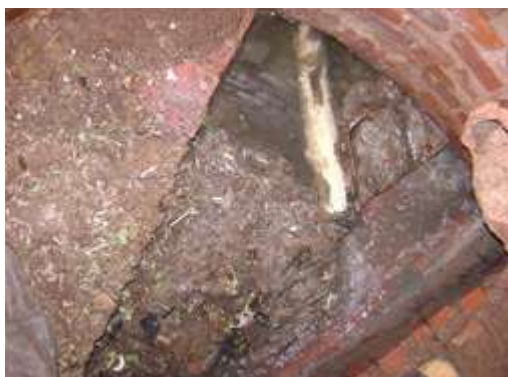
Defect 3

Comments **INCOMING 4 O'CLOCK LINE BLOCKED BY DEBRIS. INCOMING LINE AT 6 O'CLOCK IS SLIGHTLY LOWER THAT OUTGOING LINE. FLOW IS POOLING AT BASE OF DROP IN CHANNEL.**

debris blocking I6

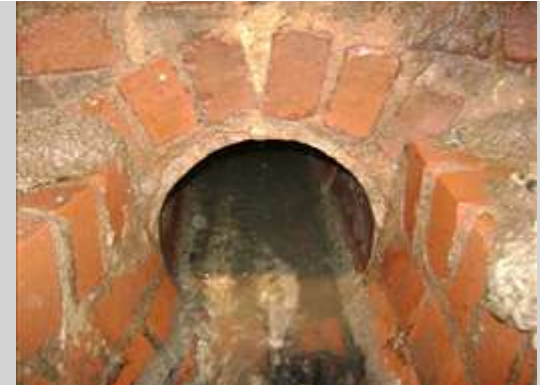
12 O'Clock Outflow

8 in. Circular Gravity Sewer  
Pipe Out @ 12 O'Clock

Pipe Height: **8.4** (in.) Rod and Bar (Angled)  
Pipe Material: **Clay** ☐ Pipe Lined  
Invert Depth: **12.46** (ft.) Flow Characteristics: **Fast**  
Deposits: ☐ None ☐ Mud ☐ Sludge ☒ **Debris** ☐ Grease  
Silt Depth: **1** (in.) Deposits Extent: **Light**  
Infiltration: **None** Pipe Seal Cond: **Sound**

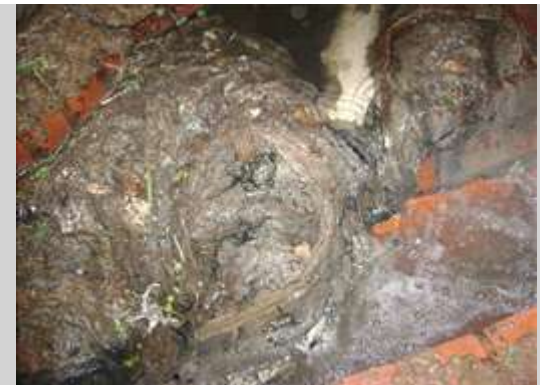
6 O'Clock Inflow

debris blocking pipe

Pipe Height: **8.4** (in.) Rod and Bar (Angled)  
Pipe Material: **Clay** ☐ Pipe Lined  
Invert Depth: **12.20** (ft.) Flow Characteristics: **Slow**  
Deposits: ☐ None ☒ **Mud** ☒ **Sludge** ☒ **Debris** ☐ Grease  
Silt Depth: **4** (in.) Deposits Extent: **Heavy**  
Infiltration: **None** Pipe Seal Cond: **Unknown**

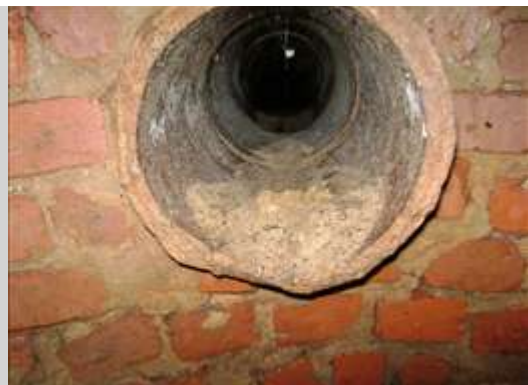
8 O'Clock Inflow

Pipe Height: **8.4** (in.) Rod and Bar (Angled)

Deposits: ☐ None ☐ Mud ☐ Sludge ☒ **Debris** ☐ Grease

Silt Depth: **0.5** (in.) Deposits Extent: **Light**

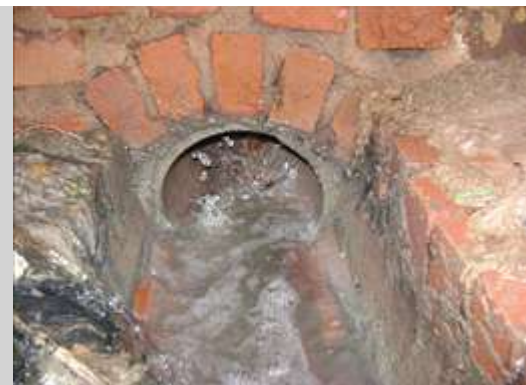
Drop In @ 8 O'Clock

Drop: **Inside** Rod and Bar

Angled: **Yes** Reading: **11.50** (ft.)

Inv Depth: **12.50** (ft.)

Drop Condition: **Open**
